# PicoZed FMC Carrier Card

## Revision C

### Errata

Thank you for your interest in the PicoZed FMC Carrier Card (PZCC-FMC). Although Avnet has made every effort to ensure the highest possible quality, these boards are subject to the limitations described in this errata notification. This document pertains to the PicoZed FMC Carrier Card Revision C.

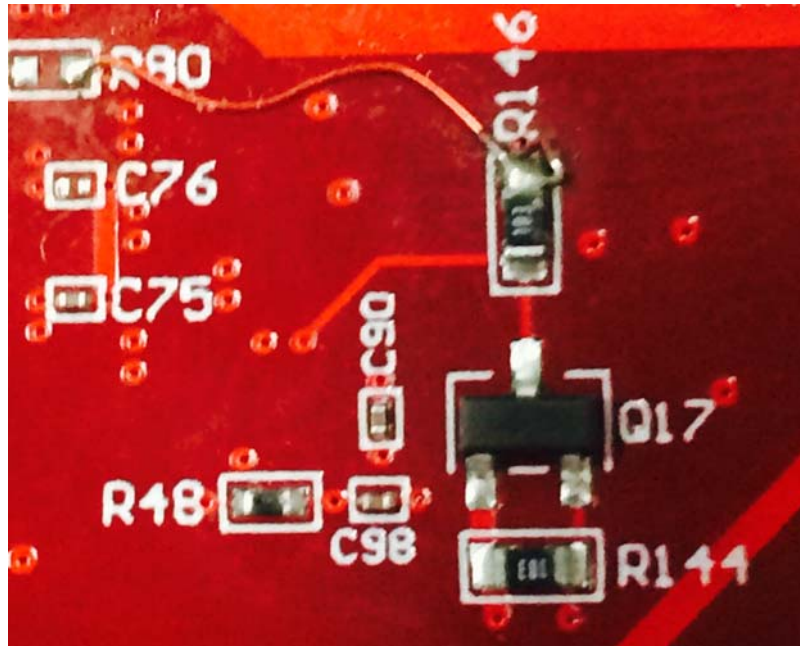
Figure 2 – Rework which changes Ethernet Port J11 to Address 0x01

The secondary Marvell 88E1512 PHY on PicoZed FMC Carrier sets the PHY's MDIO address to 0, which is the MDIO broadcast address. Since the Xilinx GMII-to-RGMII shim is also on the MDIO bus, the shim could potentially interfere with communication to the PHY (although the shim does not respond to the broadcast address as of Vivado 2014.4).

Remove R80. Wire the top of R146 to the right pad of R80. This changes the PHYAD[0] from a '0' to a '1'.

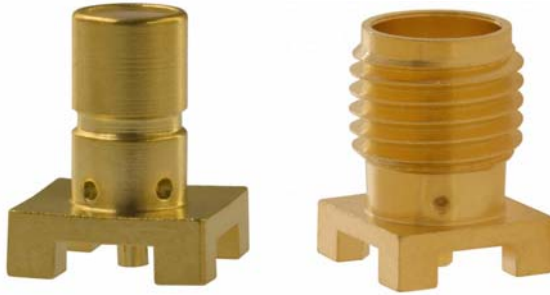
Figure 3 – SMB Connector vs SMA Connector

Located at position J15, J16, J19, J20, J21, J22, you will notice that instead of SMA connectors SMB style has been installed. While measures are in place to minimize manufacturing defects, there exists the possibility of the wrong part being placed. In this case, the SMA connector called out in the bill of material has not been placed.

If your FMC Carrier Card falls within the affected serial number range and has the SMB connectors populated you have the following options:

- If you are not working with the transceivers, these connectors are not used, no action required
- Use the connectors as-is with an SMB cable.
- Return the board to Avnet for connector replacement.
